NINTH ANNUAL SUMMARY REPORT

Flight Service Program for Advanced Composite Rudders on Transport Aircraft

DOUGLAS AIRCRAFT COMPANY
LONG BEACH, CALIFORNIA 90846

CONTRACT NAS1-12954
SEPTEMBER 1985

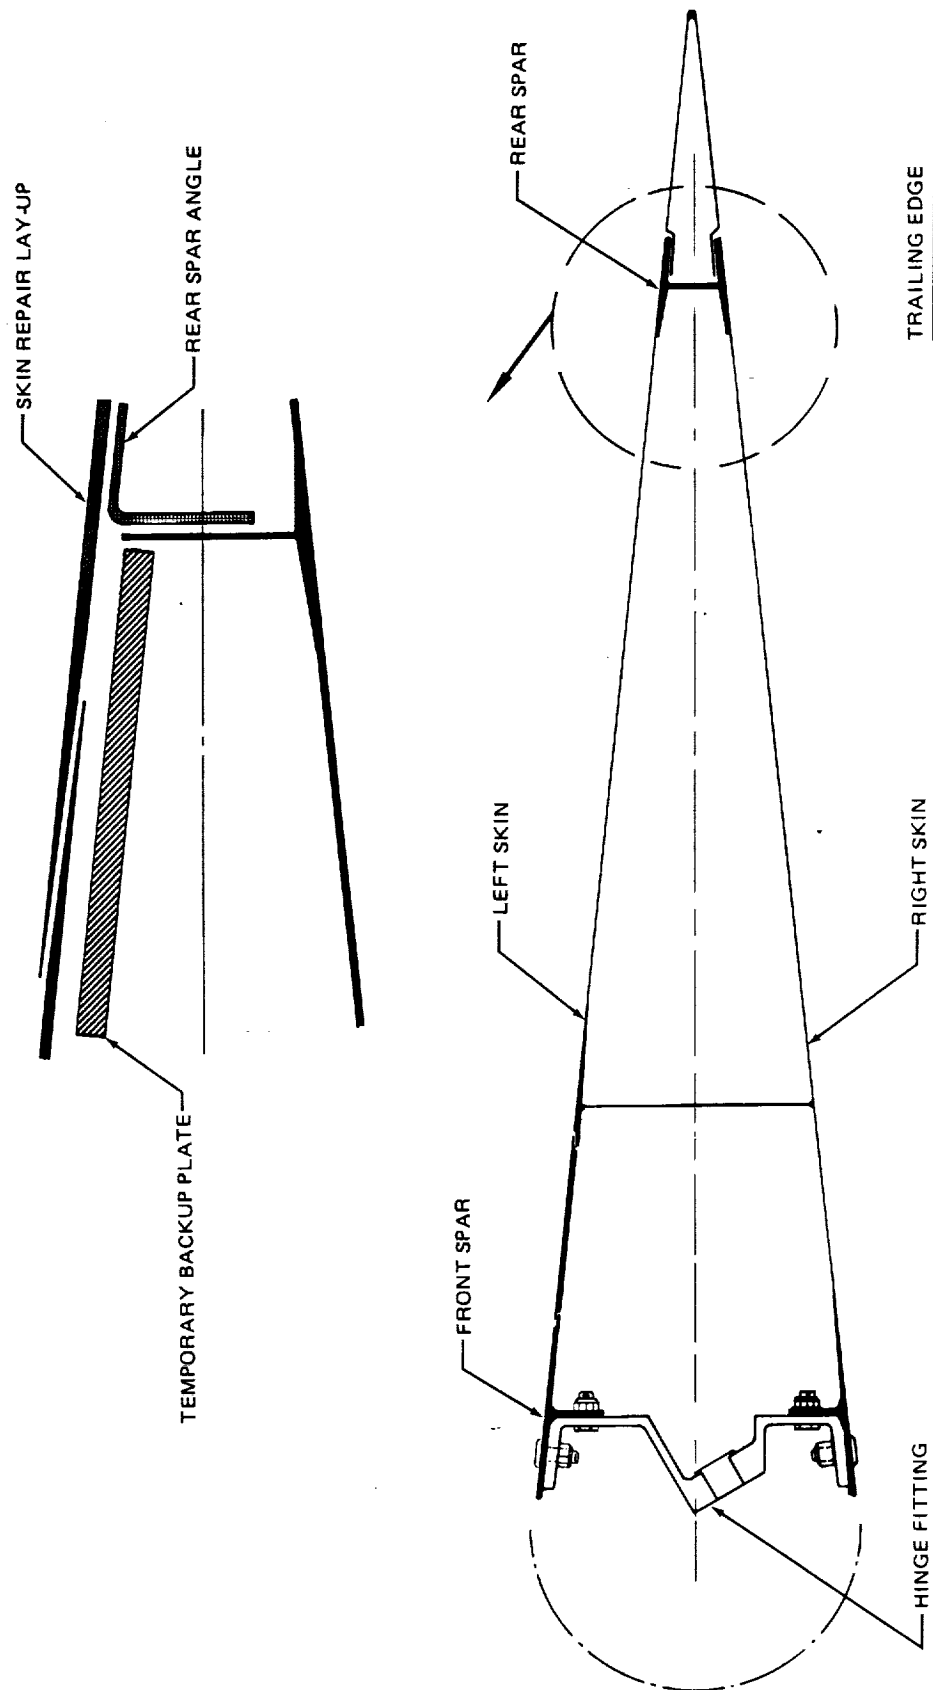
FIGURE 8. RUDDER REPAIR SCHEMATIC

The rudder repair procedure is shown in schematic form in Figure 8. The front spar access plates were removed to locate the internal backup plates. The damaged skin and spar cap were sanded until the skin was tapered at a 50:1 length-to-thickness ratio. This taper ratio was determined during the repair development program. Figure 9 shows the prepared rudder after the damage was removed and the skin was tapered.

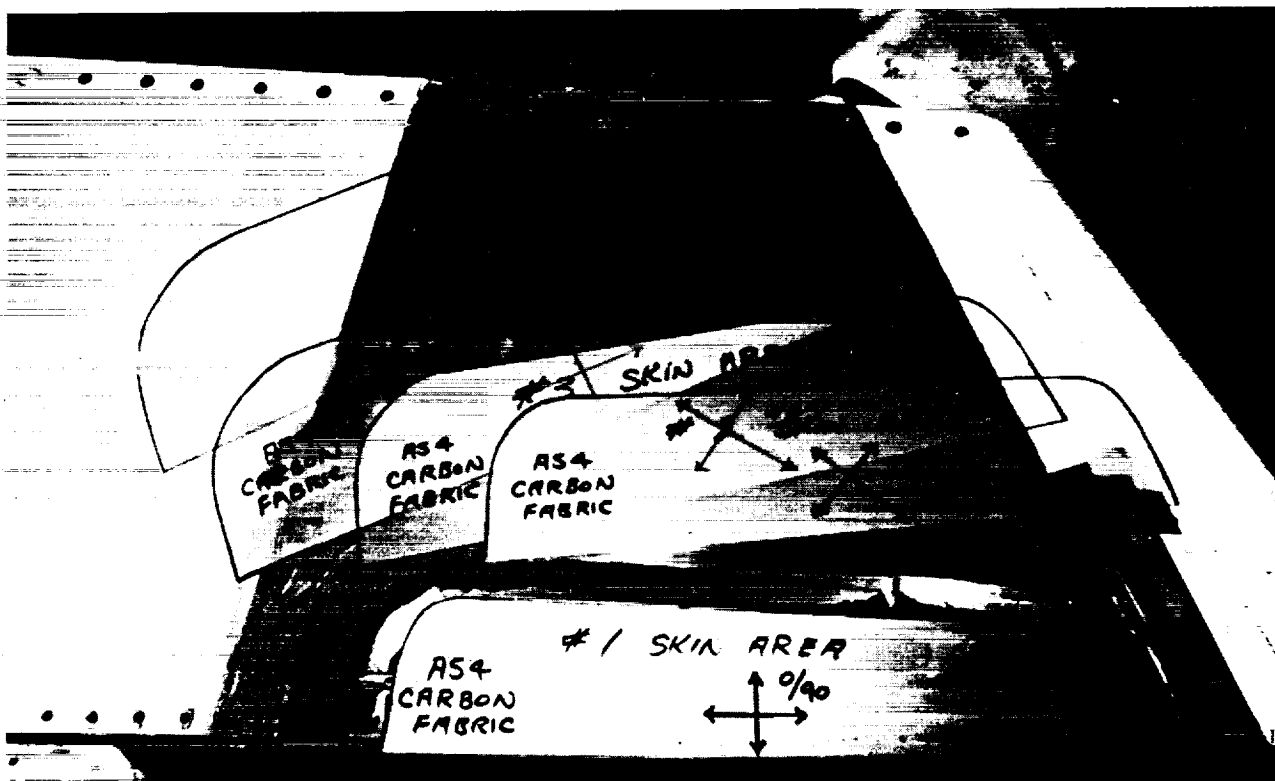
L5-05974

FIGURE 12. PLY TEMPLATES

Templates defining the skin and spar cap repair plies were cut from Mylar and checked for fit, as shown in Figure 12. The skin was prepared for bonding and the bond surface verified by water break test. A single piece of carbon cloth was then impregnated with resin, as shown in Figure 13. The individual ply pieces were cut using the template and are shown being laid in place over the skin in Figures 14 and 15. The repair zone was vacuum bagged, as shown in Figure 16, and cured under a thermocouple-controlled heat blanket. The vacuum and heat were supplied by an ACR 9000 portable controller, manufactured by the Brisk Heat Company and shown in Figure 17.
